**भारत सरकार/ Government of India**  
**विद्युत मंत्रालय/ Ministry of Power**  
**केन्द्रीय विद्युत प्राधिकरण/ Central Electricity Authority**  
**विद्युत प्रणाली अभियांत्रिकी एवं प्रौद्योगिकी विकास प्रभाग**  
**Power System Engineering & Technology Development Division**

**विषय:** Minutes of the meeting of the Standing Committee of the Experts to discuss the failure of 220 kV and above voltage level Transformers during period of January, 2025 to June, 2025-reg.

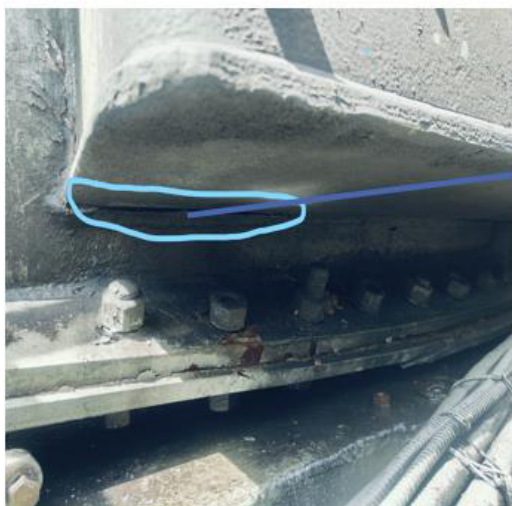
Damage and  
Oil spilling point

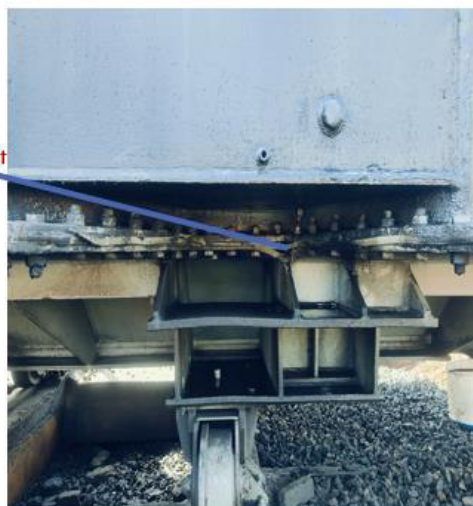
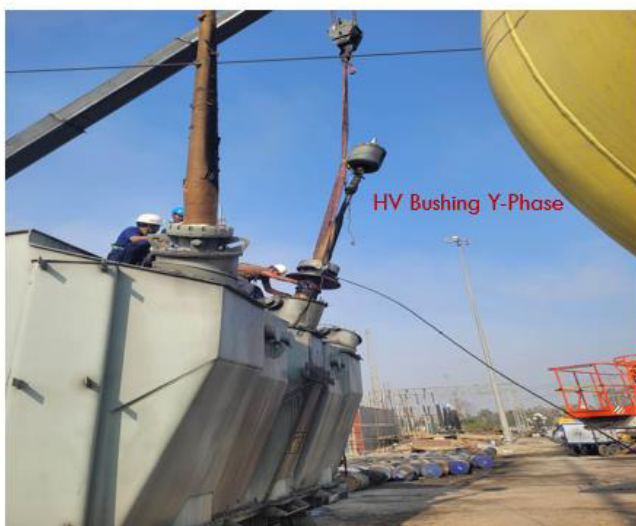
HV Bushing Y-Phase

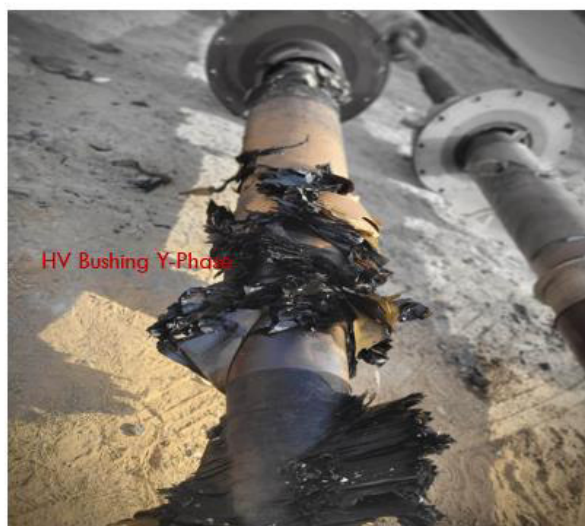
HV Bushing Y-Phase

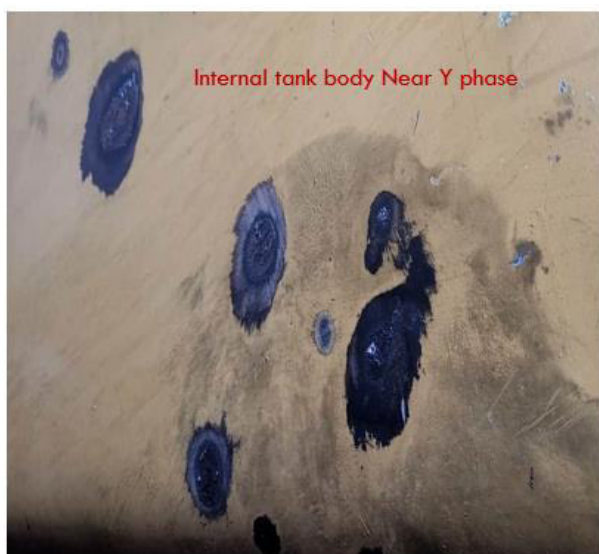
Internal tank body Near Y phase

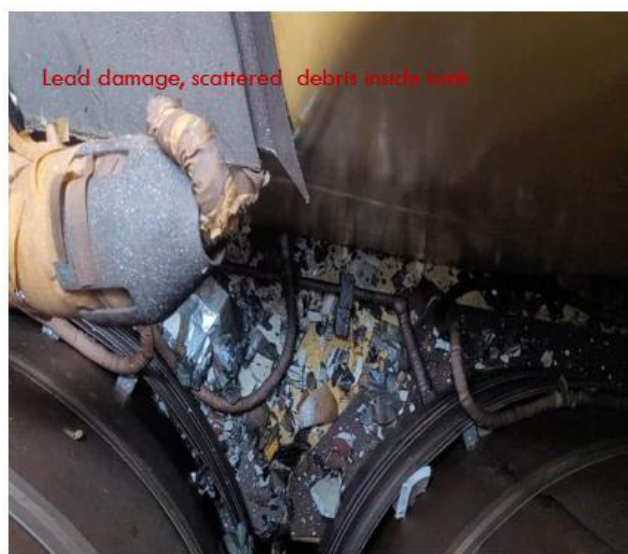
Representative from NTPC presented the case of failure of 100 MVA, 400/132 kV ICT-2 at Singrauli. ICT-2 was manufactured in the year 1981 and commissioned in 1982. ICT-2 caught fire and tripped on electrical/mechanical protection. There was no abnormality in the system at the time of failure. Previous test results of the ICT were also normal. All bushings of the ICT are completely damaged. All oil of the ICT was drained. As per the DR data, fault current of around 31 kA was observed in Y-ph. As per the preliminary report submitted by OEM, Y-Phase bushing on the HV side showed catastrophic insulation failure, external burning, sign of pitting on corona shield and delamination. R & B-phases also showed damage. R and B Phase Bushing also failed. 132 kV partially overheating marks observed. Structural deformation at bottom and Top of tank, burn marks, and pressure signs were noted on the tank, likely due to extreme high pressure due to heavy arc-generated gases inside tank. Internal inspection revealed disintegrated insulation, scattered debris, arcing signs, and thermally damaged conductors. Multiple laminations and spacers were fractured. Several internal arcing spots were visible on the transformer structure (core clamp surfaces), indicating concentrated high-energy discharge.

Lead damage, scattered debris inside tank

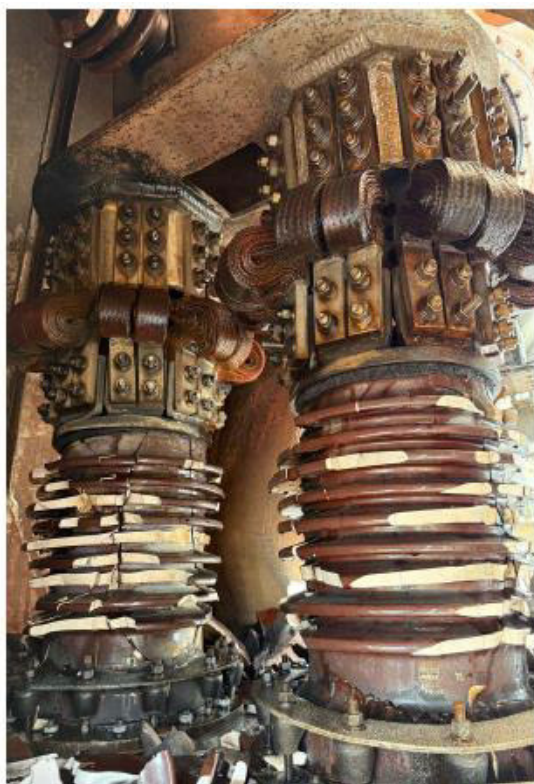
Representative of NLCIL presented the case of failure of 300 MVA, 16.5/400 kV GT-I at TPS-II Expansion, NLCIL. He stated that GT-I got tripped on differential protection and caught fire. Bulging of the transformer tank was observed which led to oil leakage. The spilled oil caused the fire. In the Protection REF, Buchholz & PRV operated. Damage of R & Y ph bushings were observed. GT LV bus duct support insulators also got damaged. Transformer emulsifier system operated. There was no Buchholz, OTI, WTI alarm prior to the failure. He further mentioned that there were no external faults in the system when the transformer failed. From relay DR it is suspected that it is a sudden inter-turn winding short circuit fault and then converted as a ground fault. From commissioning until the incident, there were no operational issues or abnormal observations reported for this transformer. All periodic inspections and routine maintenance checks confirmed that the transformer was in sound working condition. OEM was of the view that transformer may got failed due to transient over voltage. These transient may be of small duration therefore could not be able to captured in the records. However, these transient may have led to the dielectric insulation failure. It was informed that DSC test was not carried out on the Subject Transformer.

**GT LV winding lead terminal insulator  
damaged**

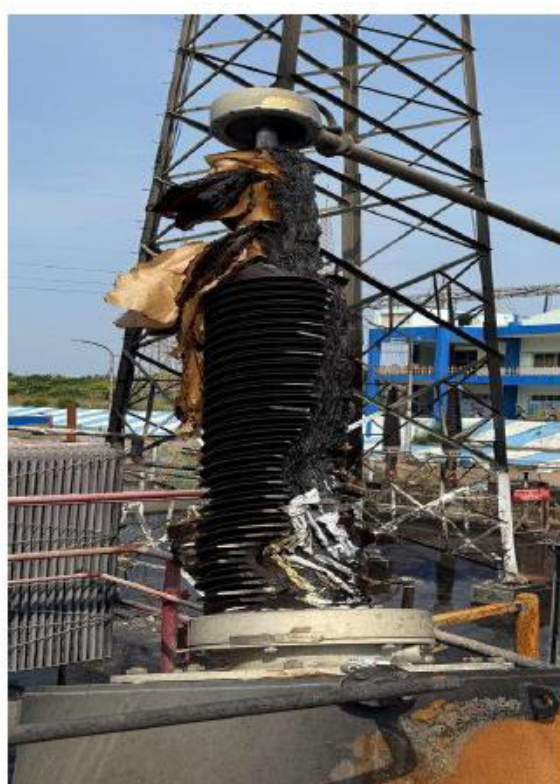
**GT HV bushing got damaged**

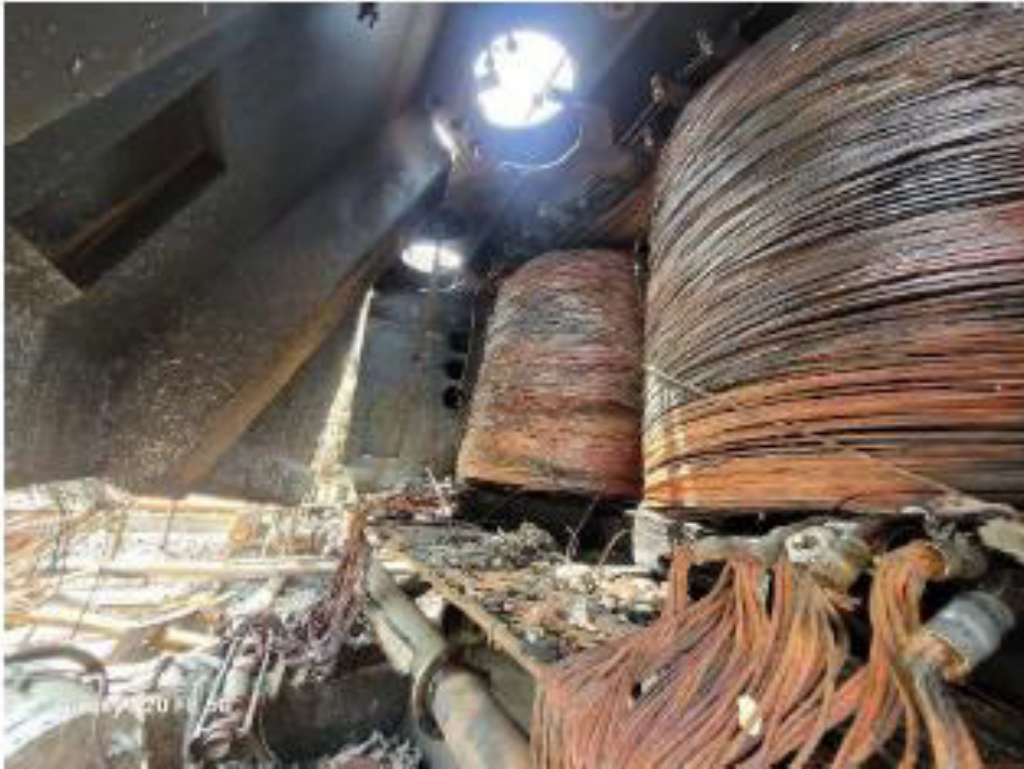
IV side winding (completely burnt)

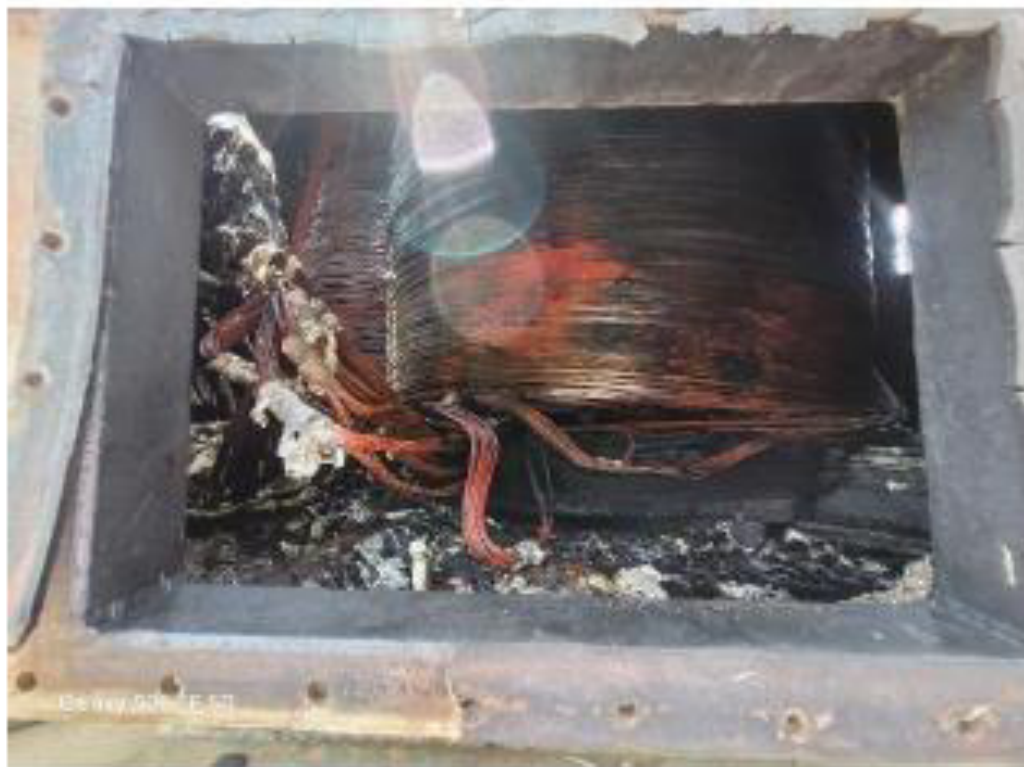
HV side winding (completely burnt)

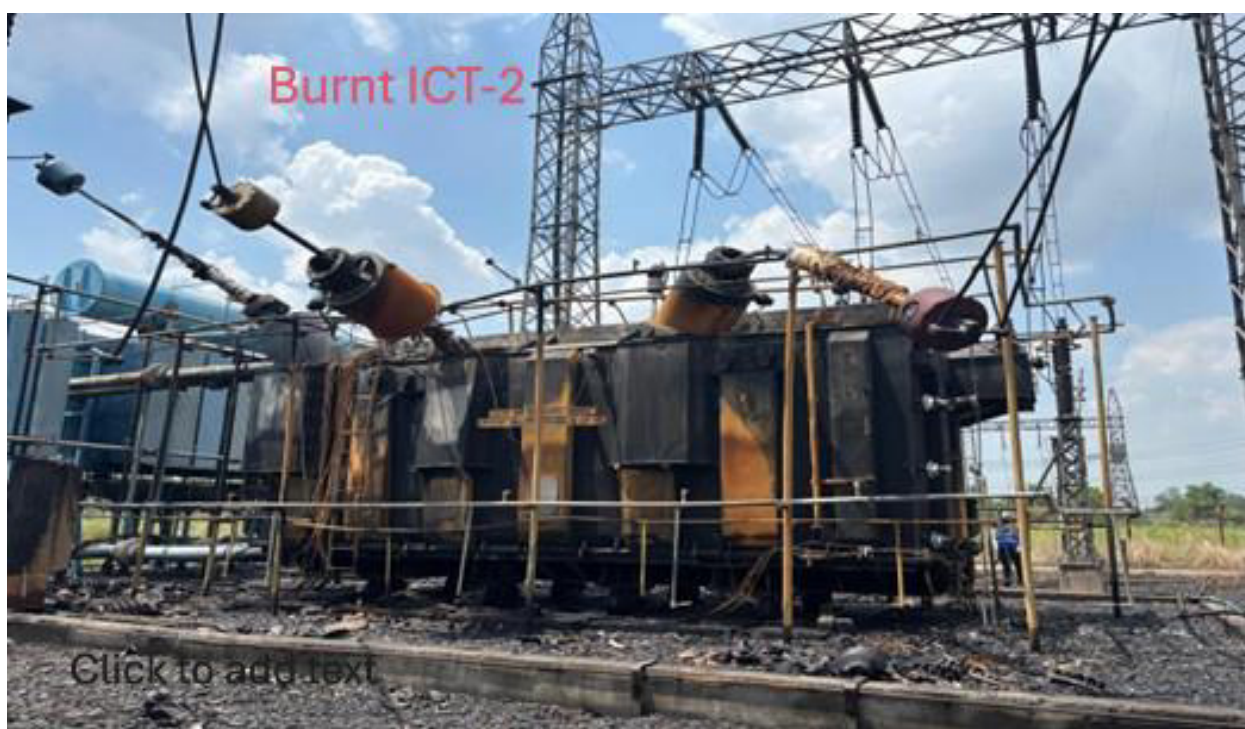
Representative of DVC presented the case of failure of 315 MVA, 400/220/33 kV ICT#2 at 400 kV Switchyard KTPS, DVC, Koderma. The ICT got tripped on Differential Protection, PRV, Buchholz relay, OTI, WTI, and OLTC on 02.06.2025 at 03:06 Hrs. The transformer caught fire immediately during the event, leading to the explosion of the High Voltage (HV), Intermediate Voltage (IV), and Low Voltage (LV) bushings. The emulsifier-based fire protection system activated automatically; however, it was insufficient to fully extinguish the fire. Consequently, the CISF fire wing was engaged in controlling and extinguishing the fire. Internal inspection of the transformer was carried out in presence of representative of BHEL and BHEL recommended that the ICT is beyond repair looking to the extensive damage in all major components. He mentioned that internal inspection team of DVC was of the view that the ICT might got failed due to bushing failure. In response, the CE (PSE&TD Division), CEA enquired whether any abnormalities had been observed in the tan delta and capacitance test results of the bushing during maintenance. To this, the DVC representative clarified that no irregularities were noted in the bushing test results. He further mentioned that maintenance/testing of the ICT was done from 20/08/2024 to 24/08/2024 & 20/01/2025 to 24/01/2025. The testing includes the Tan Delta test of all the bushings and windings, Turns ratio at existing tap (Tap 10), winding resistances (Tap 10), Magnetising current measurement, Core insulation check, IR & PI. No abnormality was observed in the test results. Root cause analysis by BHEL is under process.

**Burnt ICT**

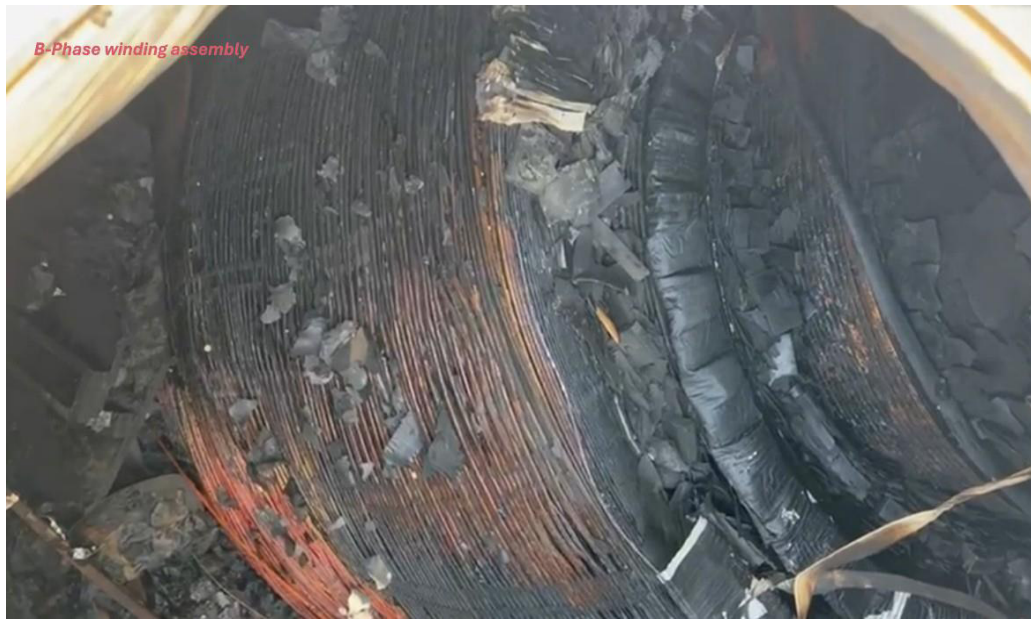
**Damaged Winding**

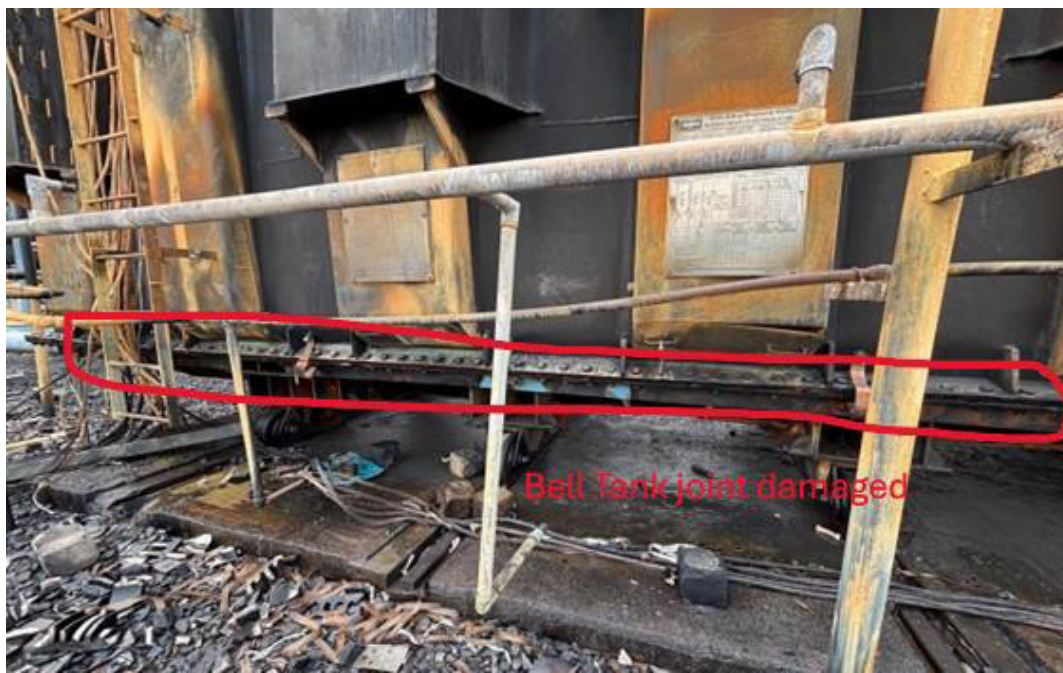
**Damaged Bell Tank Joint**
