**भारत सरकार/ Government of India**  
**विद्युत मंत्रालय/ Ministry of Power**  
**केन्द्रीय विद्युत प्राधिकरण/ Central Electricity Authority**  
**विद्युत प्रणाली अभियांत्रिकी एवं प्रौद्योगिकी विकास प्रभाग**  
**Power System Engineering & Technology Development Division**

**विषय:** Minutes of the meeting of the Standing Committee of the Experts to discuss the failure of 220 kV and above voltage level Transformers during period of January, 2025 to June, 2025-reg.

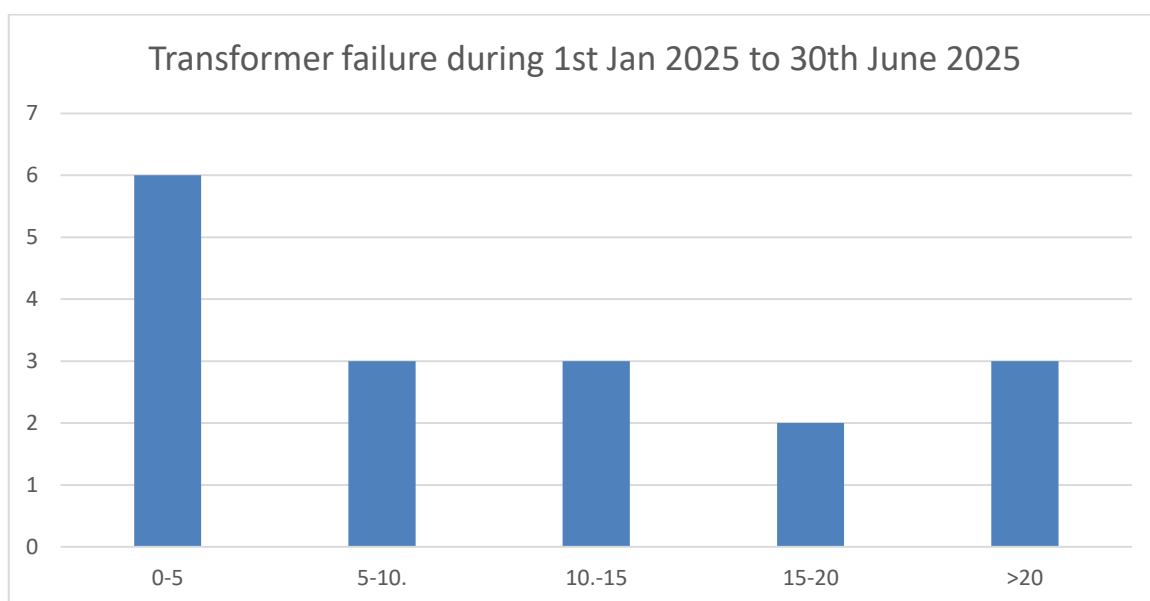
4. Out of total 17 failures of the Transformers occurred, 6 were of 220 kV class, 11 of 400 kV class and none of 765 class. 6 Nos. of Transformers failed within five years, 3 Nos. of Transformers failed in 5-10 years of period. 5 Nos. of Transformers failed during 10-20 years of their operation. 3 Nos. of Transformers failed who had operation of more than 20 years. The transformers failures that occurred between 1<sup>st</sup> January 2025 and 30<sup>th</sup> June 2025 from the commissioning of the equipment is as per the below graph below:

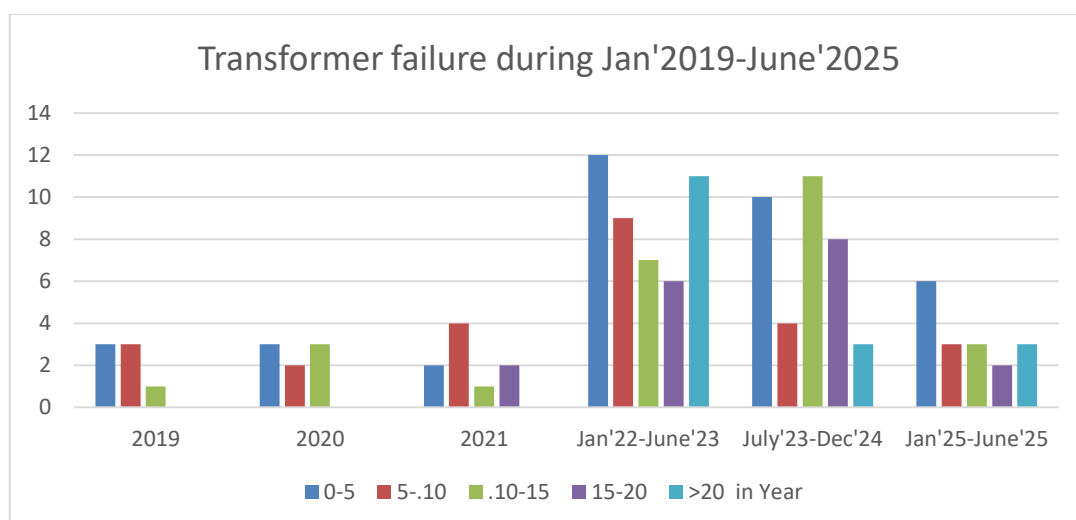
1. Failures of transformers during Jan'2019-June'2025: The number of different transformer failures as reported in the last 6.5 years to CEA has been shown in the graph below:
